Sufers (Canton of Graubünden, Switzerland) Crestawald bridge

MAPEI SOLUTIONS TO REPAIR AN IMPORTANT STRUCTURE
IN THE HISTORY OF THE SWISS CONSTRUCTION INDUSTRY

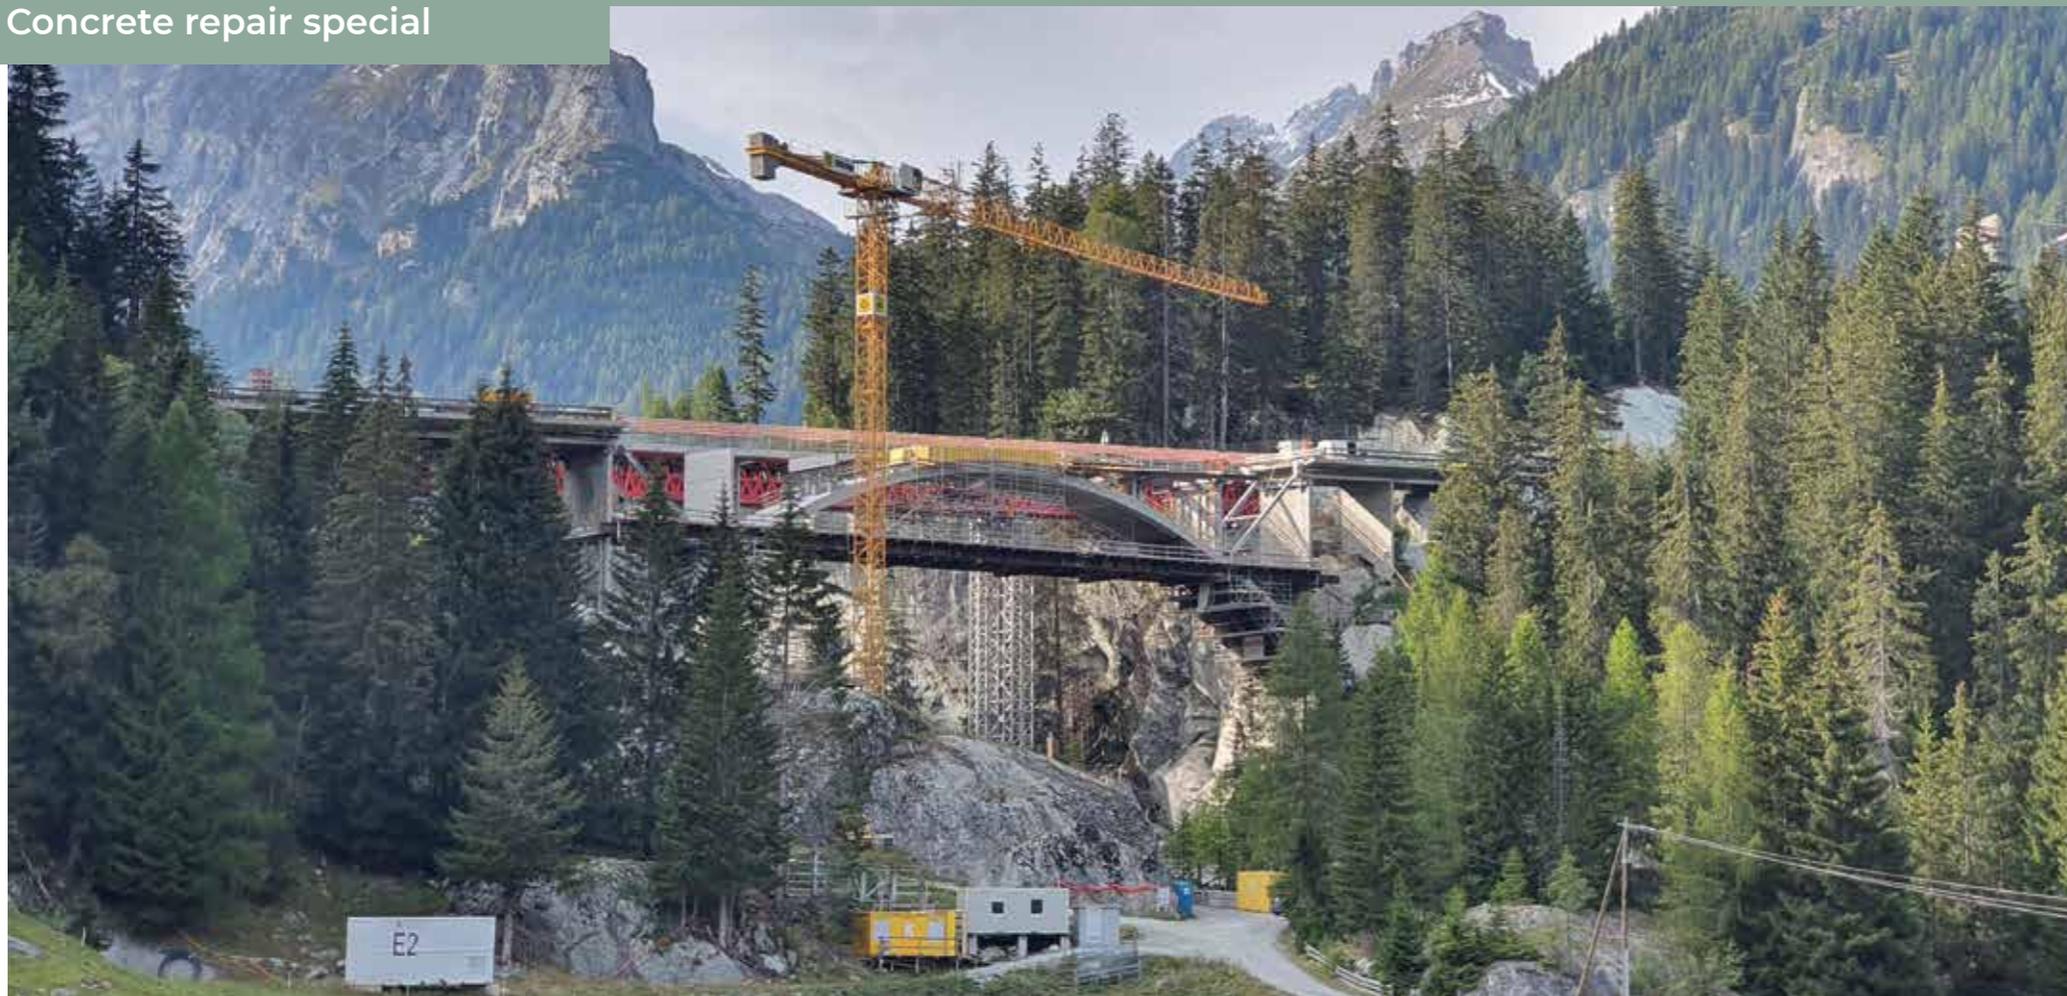
ABOVE. The Crestawald bridge is an arched structure built in 1959 that was lately refurbished.

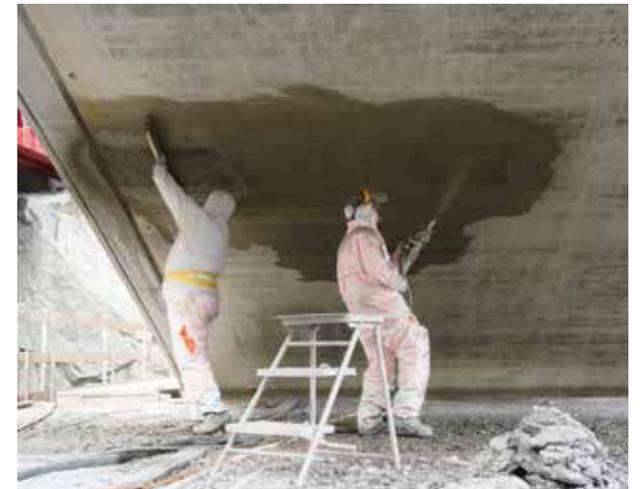
RIGHT. Several areas of deteriorated concrete were repaired with MAPEGROUT THIXOTROPIC, after protecting the reinforcing rods with MAPEFER 1K.

The reinforcing rods were cleaned by hydro-blasting without damaging it and then protected with a layer of MAPEFER 1K cementitious mortar, a product especially developed to prevent corrosion in reinforcing rods.

One of the most difficult challenges with this project was the repair works on the areas of deteriorated concrete on the intrados of the bridge. The challenge, won thanks to MAPEGROUT THIXOTROPIC, was to restore the appearance and texture of the concrete originally created using special formworks. Its thixotropic consistency made it easier to apply the product on the underside of the arch.
