Oô (Upper Garonne, France) Lake d'Oô dam

SPECIALISED ACROBATIC BUILDING TEAMS
ALSO DEPLOYED TO REPAIR CONCRETE

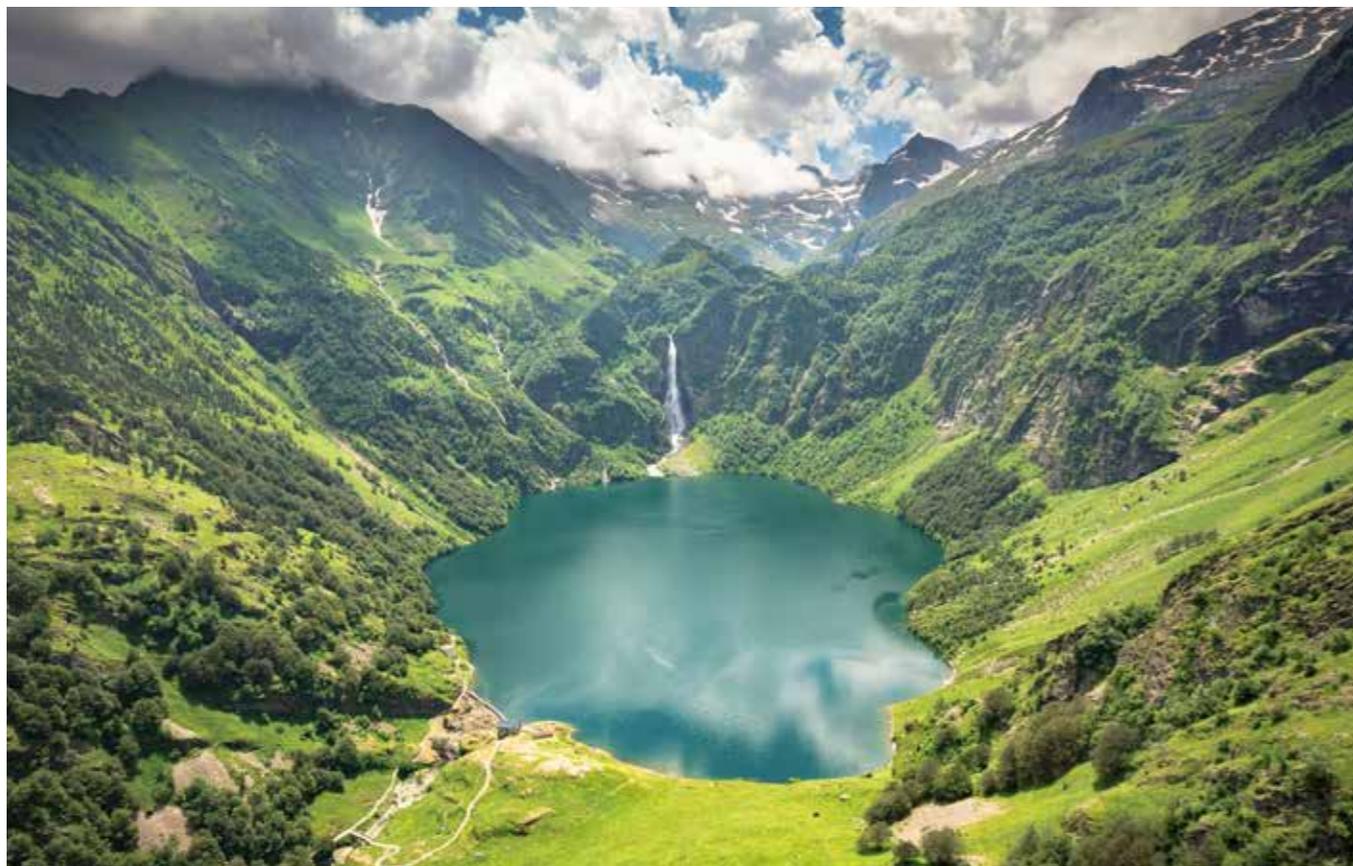
RIGHT. The dam on Lake d'Oô is situated at an altitude of 1500 m in the Pyrenees mountain range. It was recently repaired with a complete Mapei system.
BELOW. The expansion joints were sealed again with MAPEFOAM and MAPEFLEX E-PU 30 NS.

The company commissioned to carry out the work, Aevia France SUD, contacted Mapei with a request for a proposal for a complete system to repair the downstream face of the dam wall. The work was carried out by specialised teams working suspended from ropes and cables without the use of scaffolding and with the support of the Mapei France Technical Services Division who provided the right training on how to apply the products. The reinforcement rods in the deteriorated areas were protected with MAPEFER 1K, anti-corrosion mortar. Before using the repair mortar, a coat of bonding slurry made with PLANICRETE LATEX was applied on the surfaces.

MAPEGROUTT60 F, a fibre-reinforced thixotropic mortar that is manufactured and distributed on the French market by Mapei France, was then used to repair the deteriorated areas. The cast iron covers for the drains at the foot of the dam were sealed

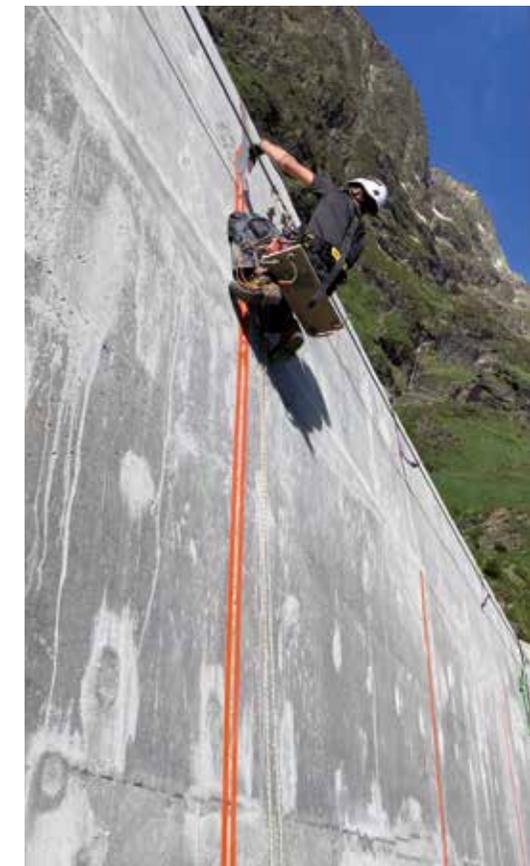
Find out more
MAPEFLEX E-PU 30 NS

with MAPEFILL MC compensated-shrinkage concrete, which is also manufactured and distributed in France by Mapei France. The distribution joints on the dam wall, which by now were completely worn, were sealed by applying MAPEFOAM closed cell polyethylene foam cord along the bottom of the joints and then sealing the joints with MAPEFLEX E-PU 30 NS two-component, high-strength, epoxy-polyurethane sealant. This system allowed both the vertical joints and the horizontal joints to be repaired. When replacing the sluice gate for the drain at the foot of the dam, IDROSTOP hydrophilic expandable rubber profile was chosen to make sure the joints were perfectly waterproof, which was bonded in place with IDROSTOP MASTIC thixotropic adhesive.
