## Málaga (Spain)

# Mayoral logistics hub

A FORMER INDUSTRIAL COMPLEX RECONVERTED WHILE MAINTAINING THE IMPOSING 200 M STRUCTURE INTACT

### Restoration and strengthening work on the structure

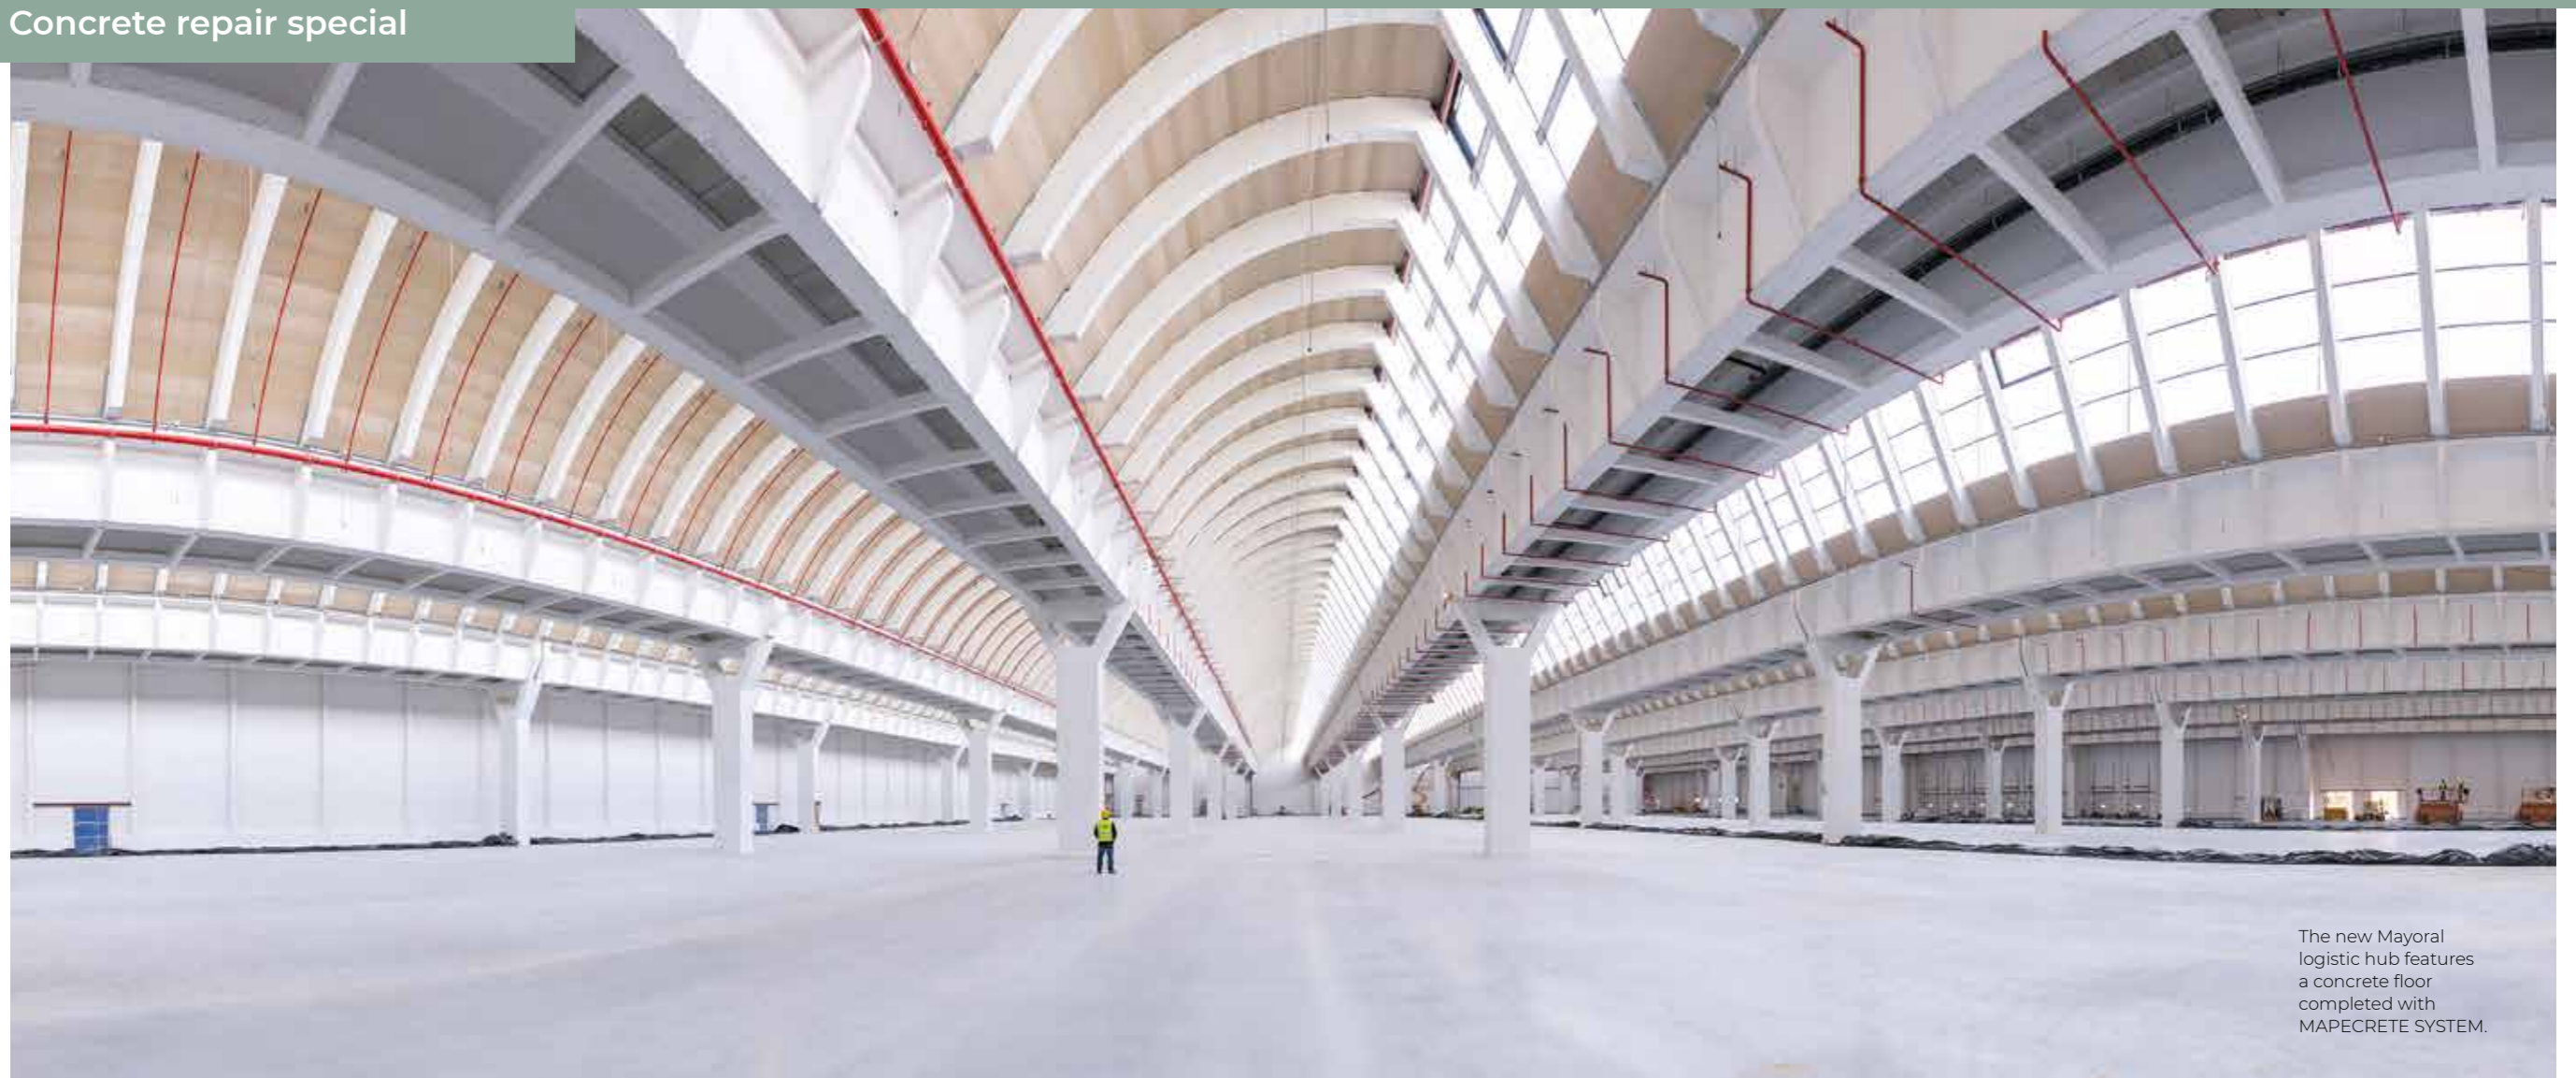
The new Mayoral logistic hub features a concrete floor completed with MAPECRETE SYSTEM.

Once all the renovation and repair work had been completed, a new concrete floor was installed inside the structure using the MAPECRETE SYSTEM. The use of the expansive agent EXPANCRETE for shrinkage-compensated concrete, the admixture MAPECURE SRA (specifically formulated to reduce the formation of cracks due to hygro-metric shrinkage in concrete by up to 50%) and the plasticizers DYNAMON FLOOR 3 (which is manufactured and distributed by Mapei Spain) and MAPEFLUID AC40 enabled a high quality, shrinkage-compensated concrete floor with high dimensional stability and fewer joints to be created.

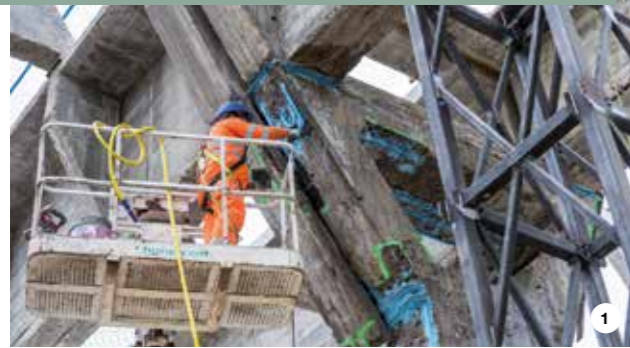
**1.** MAPEFER 1K, one-component, corrosion-inhibiting cementitious mortar, was used to protect reinforcement rods. **2.** MAPEGROUT SV T and MAPEGROUT EASY FLOW were used to repair several areas of the concrete pillars. **3.** After concrete was repaired, the surfaces were protected against carbonation by applying a coat of ELASTOCOLOR PAINT crack-resistant, elastomeric coating. **4.** A new high performance concrete floor was completed with MAPECRETE SYSTEM.

their specific area of use: the areas where only the surface needed to be refurbished were hydro-blasted and the surface was removed mechanically, while in the areas with more serious signs of deterioration larger portions of concrete were removed leaving the reinforcement rods exposed, which were then protected with MAPEFER 1K one-component, corrosion-inhibiting cementitious mortar, specific for protecting reinforcement rods.
