Milan (Italy)

Cavo Redefossi sewer

A BESPOKE FIBRE-REINFORCED MORTAR EMPLOYED FOR CONSOLIDATING A MASONRY CANAL USED AS SEWER

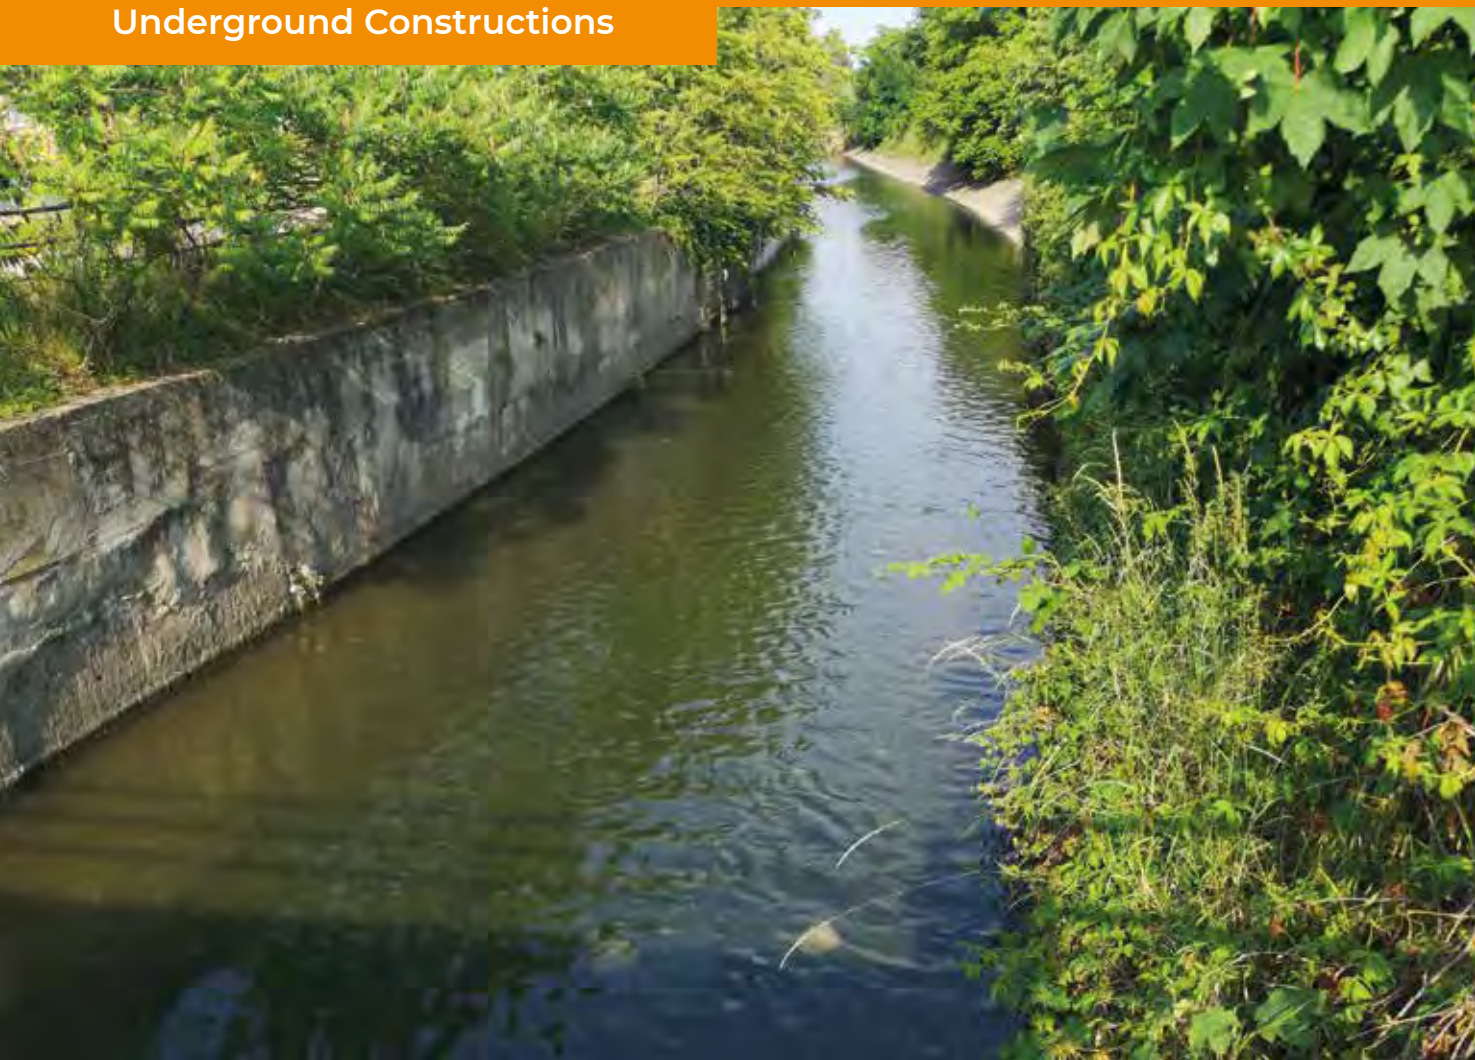
Cavo Redefossi canal was built in 1783-1786 in Milan and lately consolidated and repaired.

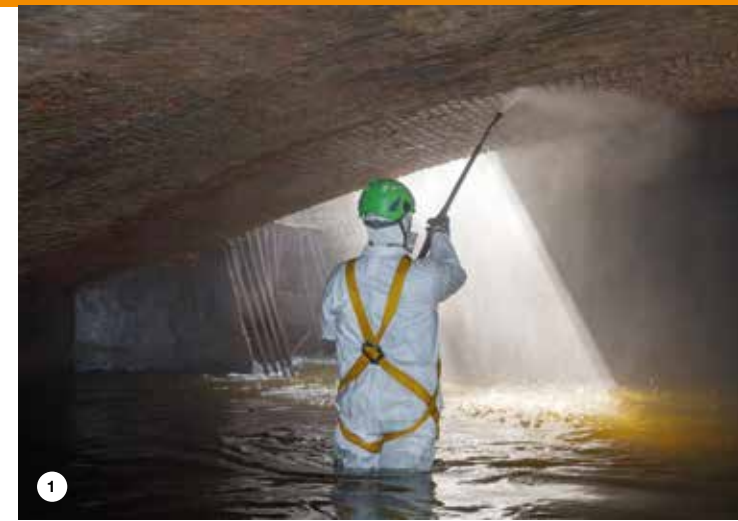
1. Repair works started by hydro-scarifying the substrates to ensure perfect adhesion of the following layers.
2. Installing the steel mesh between the two layers of MAPEGROUT FMR-PP.
3. Applying MAPEGROUT FMR-PP by spray.

To repair the vaulted ceiling, the first step was to hydro-scarify the surface to create a solid, resistant and rough substrate. The substrate was then saturated with water. Once the water had evaporated off, a layer of MAPEGROUT FMR-PP was applied by spray. Once this layer had dried, steel mesh was applied on the surface and then covered with another layer of MAPEGROUT FMR-PP for a total thickness of 20 cm.
