## Bagnarola, Sesto al Reghena (Pordenone, Italy) Piazza IV Novembre

The first one of its kind, this project involved the recovery of old, badly deteriorated porphyry paving and its re-use for the same site.

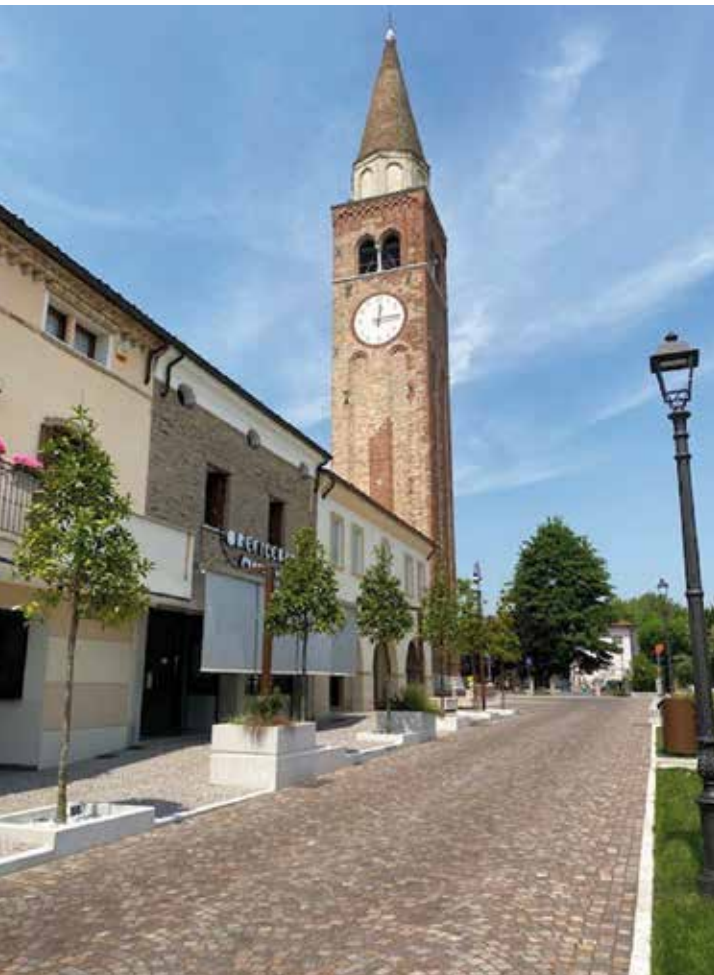
The old 4/6 cm porphyry paving cubes were recovered by cleaning them in a tumbler and then carefully selecting the ones that could be re-used, thanks to which it was then possible to create a new, protected pedestrian zone (stress class P6 according to Italian standard UNI 11714-1) with bars and shops. The road part of the piazza on the other hand, designed to include a drainage function, was paved with new 6/8 x 6/8 cm cubes sealed with MAPESTONE JOINT polyurethane binder.

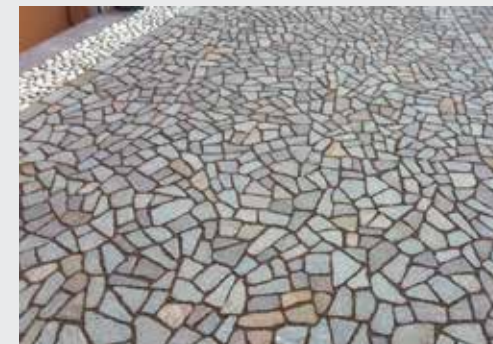
Paving made from assorted sizes of recovered cobblestones, cubes and irregular stone units sealed with MAPESTONE JOINT.

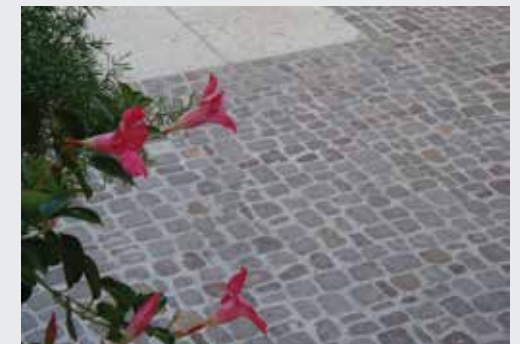
Cobbles and cubes in various sizes were installed in a characteristic pattern and grouted with MAPESTONE PFS2 to make it easier for pedestrians to walk cross.
