## Barcelona Casa Batlló

### STRUCTURAL STRENGTHENING WORK AND RESTORATION OF THE CRYSTAL SPHERES ON THE CHIMNEYS

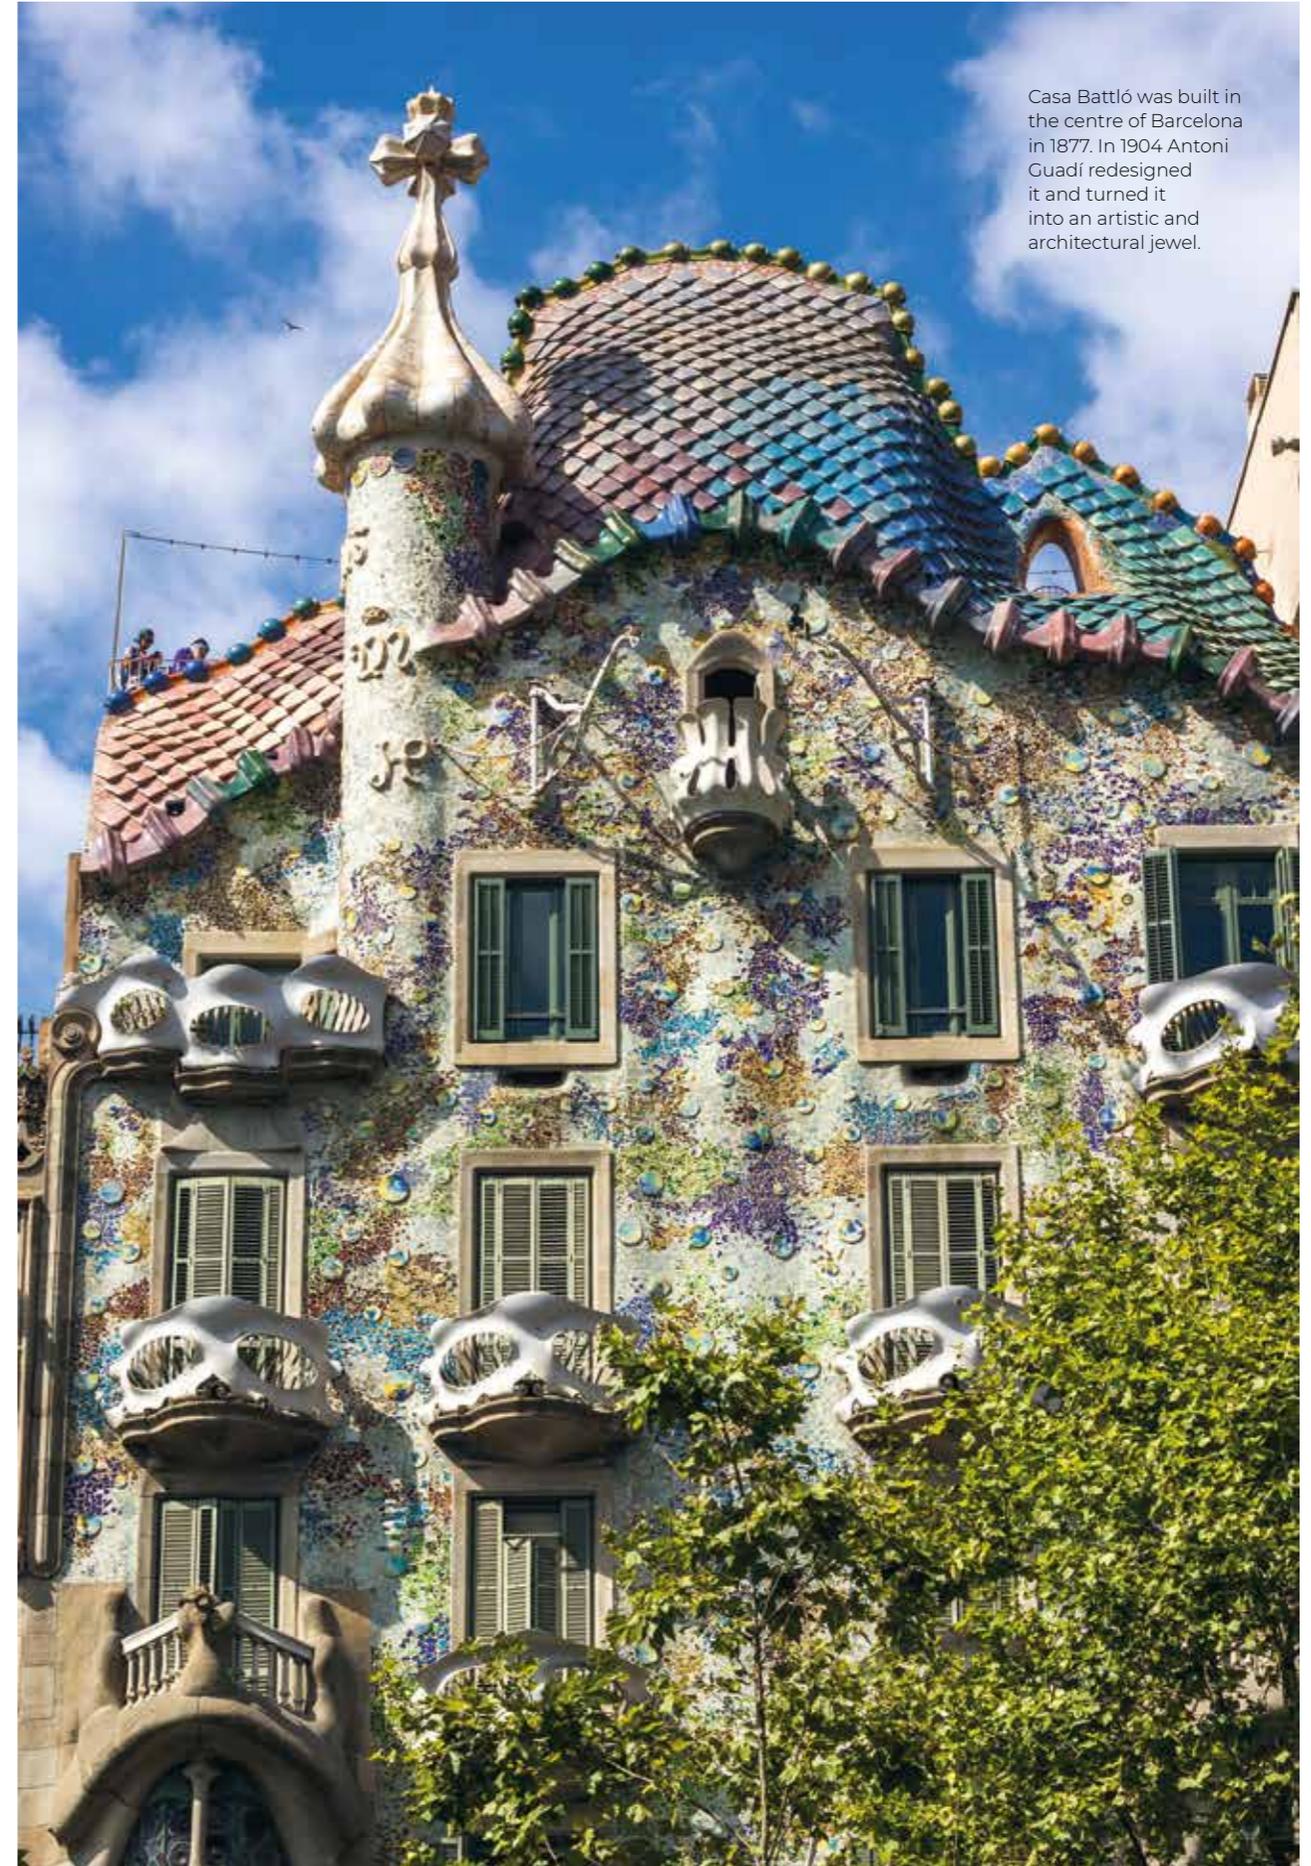
Casa Batlló was built in the centre of Barcelona in 1877. In 1904 Antoni Gaudí redesigned it and turned it into an artistic and architectural jewel.

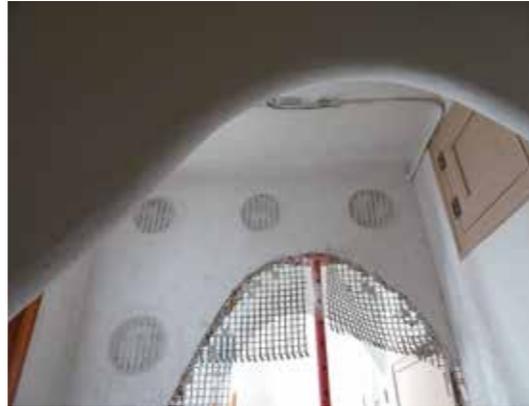
**RIGHT.** Structural strengthening work was carried out on the arches, vaulted ceilings and masonry using a system consisting of PLANITOP HDM RESTAURO, MAPEGRID G 220 and MAPEWRAP G FIOCCO.

Work started with the application of a first coat of PLANITOP HDM RESTAURO two-component, pre-blended, fibre-reinforced, high ductility mortar made from natural hydraulic lime (NHL) and Eco-Pozzolan to level off the substrate. MAPEGRID G 220 alkali-resistant glass fibre mesh was then placed on the mortar, a product which is particularly recommended for “reinforced” structural strengthening work on stone, brick, tuff and mixed masonry structures.

that it could be folded back onto the opposite side and the reinforcement intervention could be completed by making an overlap. Holes were drilled in the masonry and MAPEWRAP G FIOCCO unidirectional high strength glass fibre cords were inserted into the holes, creating a series of “structural connections” inside the existing masonry. Then, a second layer of PLANITOP HDM RESTAURO was applied to complete the intervention. A final skim coat was applied to the masonry using MAPE-ANTIQUÉ FC CIVILE, a transpirant, salt-resistant, fine-grained mortar made from lime and Eco-Pozzolan. The same system was used for the structural strengthening work on the arches and vaulted ceilings in several areas inside Casa Batlló and in the attic. PLANITOP HDM RESTAURO, reinforced with MAPEGRID G 220, was also applied on the sub-

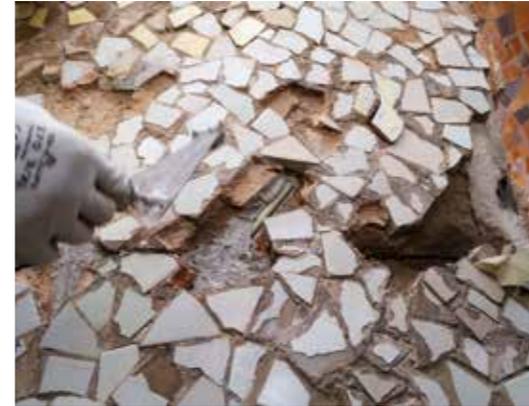
On the external faces of the vaulted ceilings, some of the cracks were “stitched” using MAPEROD G glass fibre rods.

strate for the trencadis (or broken mosaics), the glass and ceramic mosaic covering of the façade, to repair the old cracks and prevent them opening up and fracturing the ceramic coverings. Instead of using a mortar, MAPEROD G pultruded glass fibre bars were used for crack-stitching, as this product is ideal for repair and structural strengthening work on damaged concrete, wood and masonry elements.

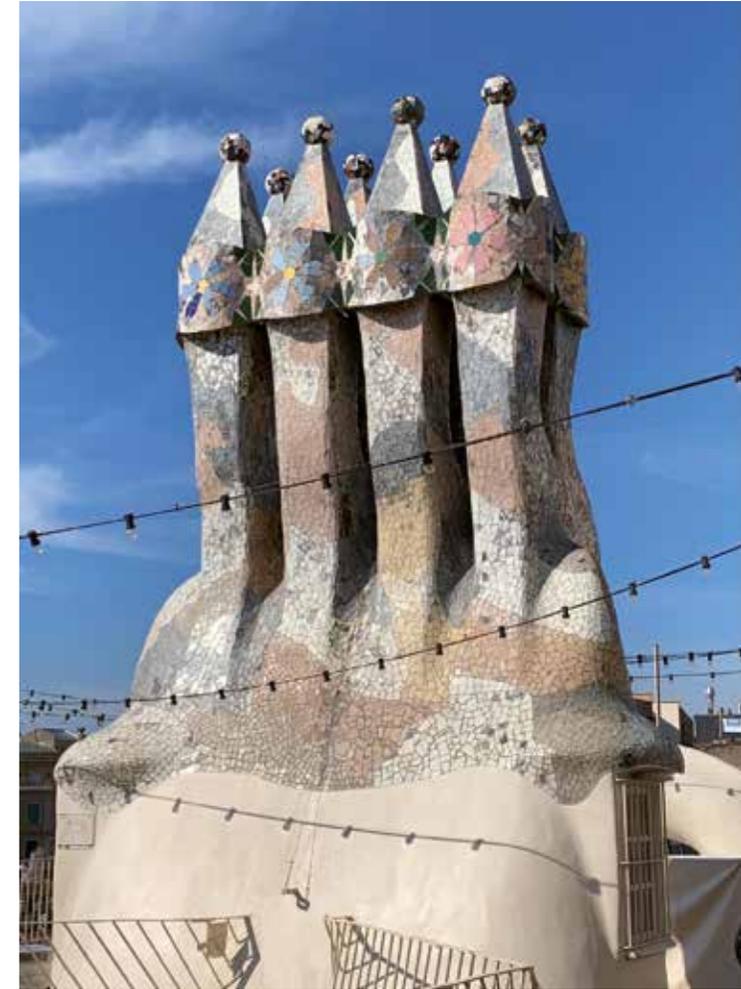
**ABOVE.** The crystal spheres were fastened to the tops of the chimneys using MAPEWRAP G FIOCCO impregnated with MAPE-ANTIQUÉ I.

Mapei also left its mark on the “highest” points of the work by Gaudí. In fact, through its subsidiary Mapei Spain, the Mapei Group was involved in the restoration work on the crystal spheres positioned above the chimneys towering over the roof of Casa Batlló. To fasten the spheres to the mouths of the chimneys, MAPEWRAP G FIOCCO glass fibre cord was used again, this time impregnated with MAPE-ANTIQUÉ I super-plastic, salt-resistant, fillerized hydraulic binder made from lime and Eco-Pozzolan, which is normally used to make injection slurry for consolidating stone, brick, tuff and mixed masonry.
