## *Milan (Italy)*

# MILAN WATER TREATMENT PLANT

AN ANTIQUE BUILDING, NOW WORKING AS A MUSEUM, HAS BEEN BROUGHT BACK TO LIFE THANKS TO THE USE OF SPECIAL PRODUCTS FOR THE RENOVATION OF MASONRY

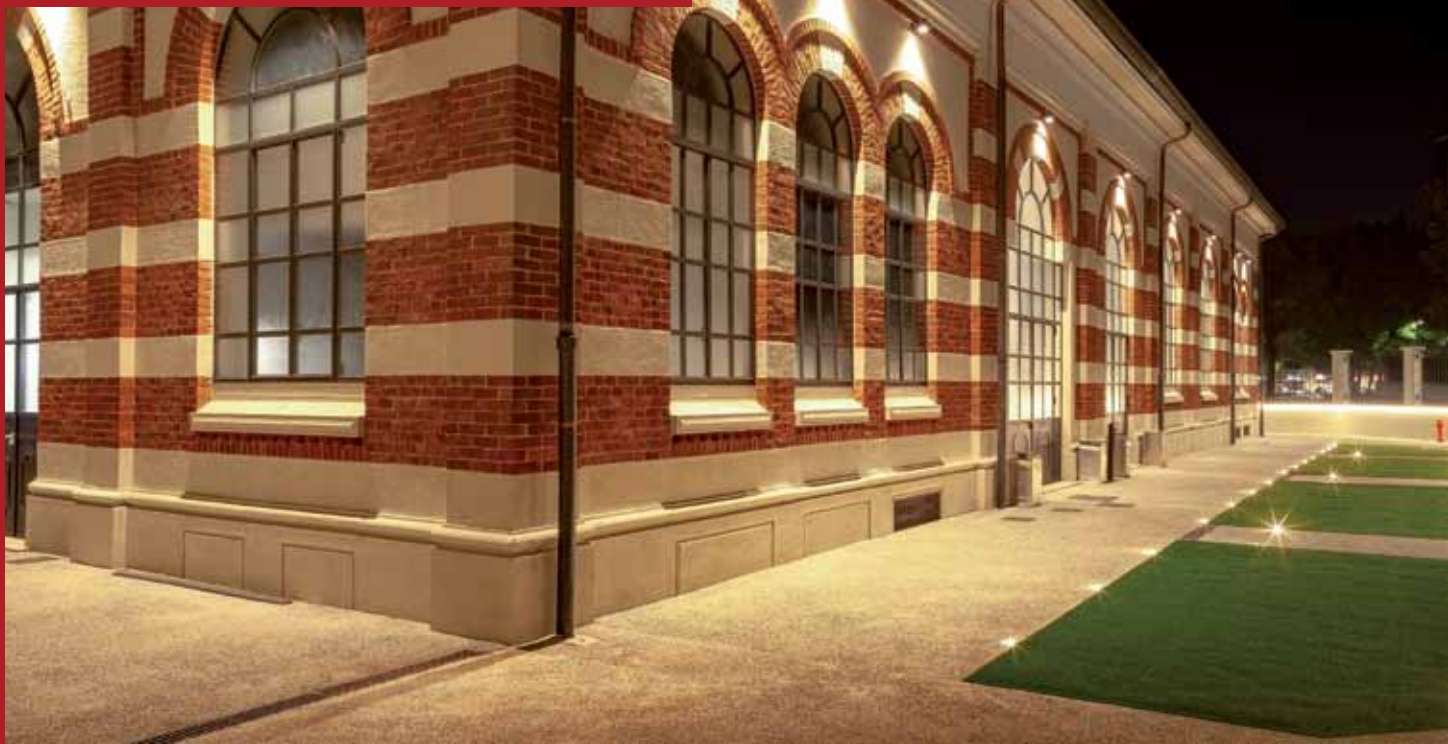
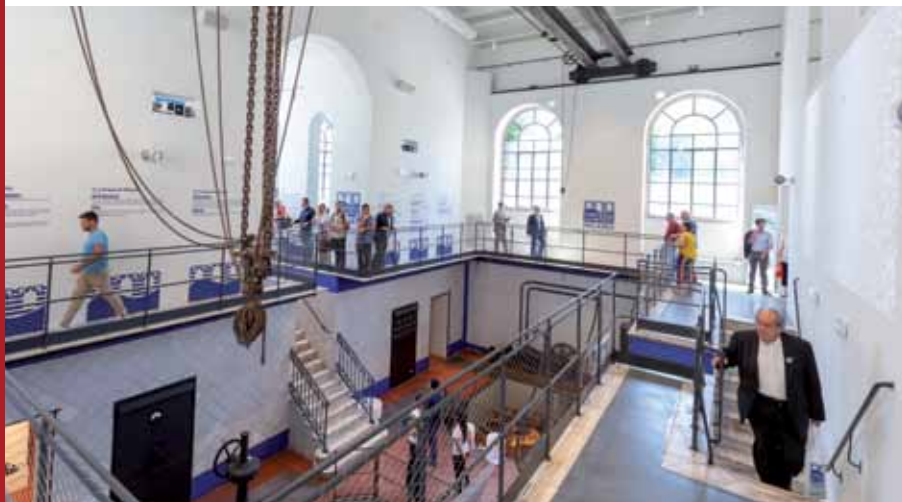
**PHOTOS 1 and 2.** After cleaning the surfaces, they were levelled with MAPE-ANTIQUE STRUTTURALE NHL, treated with PRIMER 3296 consolidator, and protected with MAPE-ANTIQUE ECOLASTIC coating.

faces had been carefully cleaned to remove any loose or detached material, a 2 cm layer of MAPE-ANTIQUE STRUTTURALE NHL mortar was applied to level the surfaces, followed by a coat of PRIMER 3296 consolidating primer, diluted 1:1 with water, and two coats of MAPE-ANTIQUE ECOLASTIC coating, to form a 2-3 mm thick layer. MAPE-ANTIQUE ECOLASTIC is an elastic coating protecting the surface of rendered masonry (including in listed buildings) from seawater, deicing salts or soluble salts in general. A base layer was created thereupon using MAPE-ANTIQUE ECO RINZAFFO salt-resistant, natural hydraulic lime and Eco-Pozzolan scratch-coat, an ideal base for dehumidifying, breathable and "structural" renders. The next step was to apply MAPE-ANTIQUE ECO RISANA dehumidifying rendering mortar, followed by two coats of MAPE-ANTIQUE ECO RASANTE CIVILE fine-grained, smoothing and levelling mortar.

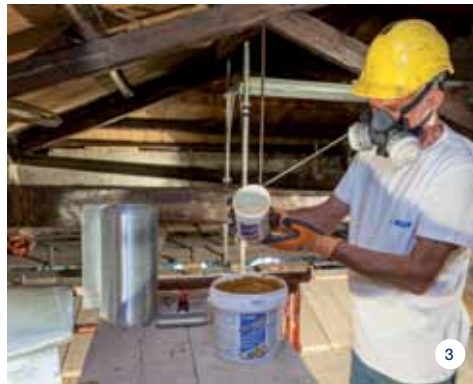
**PHOTO 3.** The exposed beams of the timber roof truss were consolidated with MAPEWOOD PRIMER 100, MAPEWOOD PASTE 140 and MAPEWOOD GEL 120.

The exposed beams of the timber roof truss were consolidated and strengthened by treating the surfaces with MAPEWOOD PRIMER 100 and applying MAPEWOOD PASTE 140, a thixotropic epoxy adhesive for restoring timber structural elements, and then MAPEWOOD GEL 120 epoxy-based adhesive, this time in the form of gel.

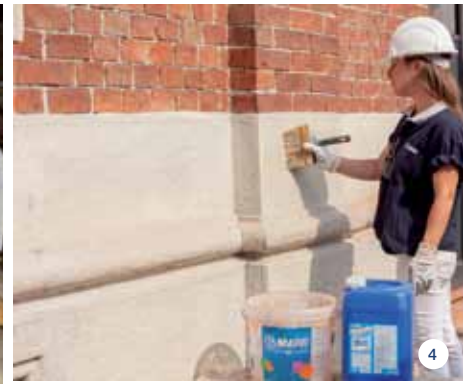
**PHOTO 4.** The facades were finished with SILEXCOLOR PRIMER and SILEXCOLOR PAINT.

The facades were finished off with silicate-based SILEXCOLOR PRIMER and SILEXCOLOR PAINT, an one-component modified potassium-silicate-based paint for internal and external vertical surfaces.
