## Philadelphia (Pennsylvania) THE MET PHILADELPHIA

**REPAIR MORTARS** AND A CUSTOMIZED COATING HELPED TO **REVIVE A HISTORIC** THEATRE

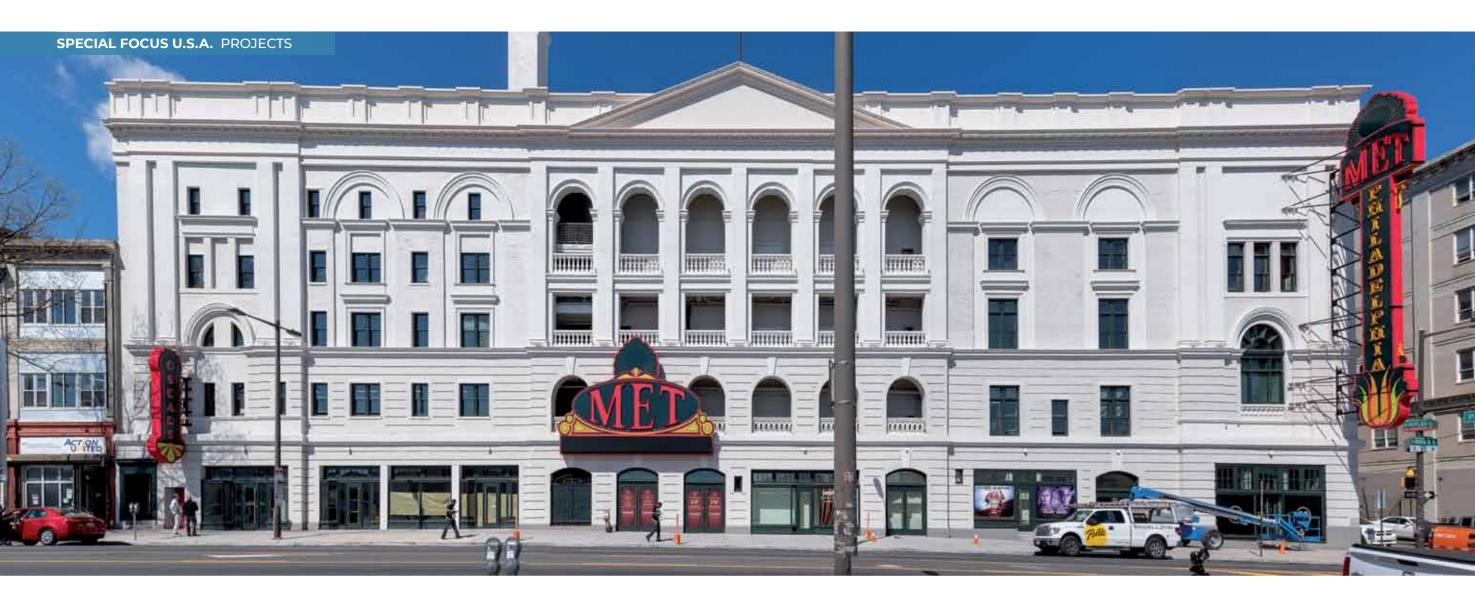
1, 2. Several concrete repair solutions by Mapei were used on different areas of the building, before applying ELASTOCOLOR TEXTURE coating. 3. Thanks to Mapei products, the MET has been restored to its original glory.
