Genoa (Italy)

SAN GIORGIO BRIDGE:
THE SPIRAL RAMP

REPAIRING, STRENGTHENING AND WATERPROOFING THE SPIRAL RAMP THAT CONNECTS THE BRIDGE TO THE A7 MOTORWAY

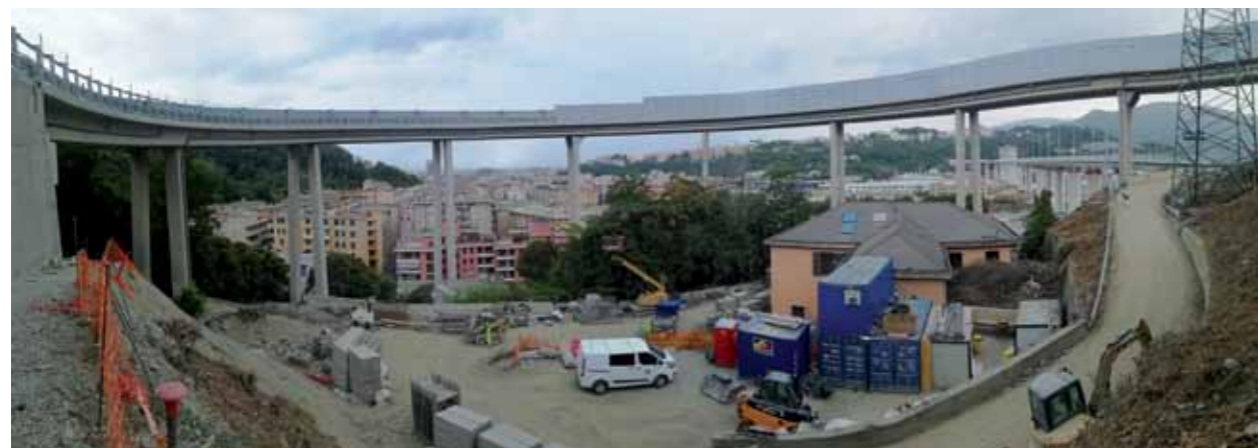
ABOVE. Repair work was carried out on both the intrados and the extrados of the bridge deck. Various products by Mapei were used for the job, including MAPEGROUT EASY FLOW fibre-reinforced thixotropic mortar and the hi-flow mortars MAPEGROUT GF BETONCINO B1 and MAPEGROUT HI-FLOW B2.

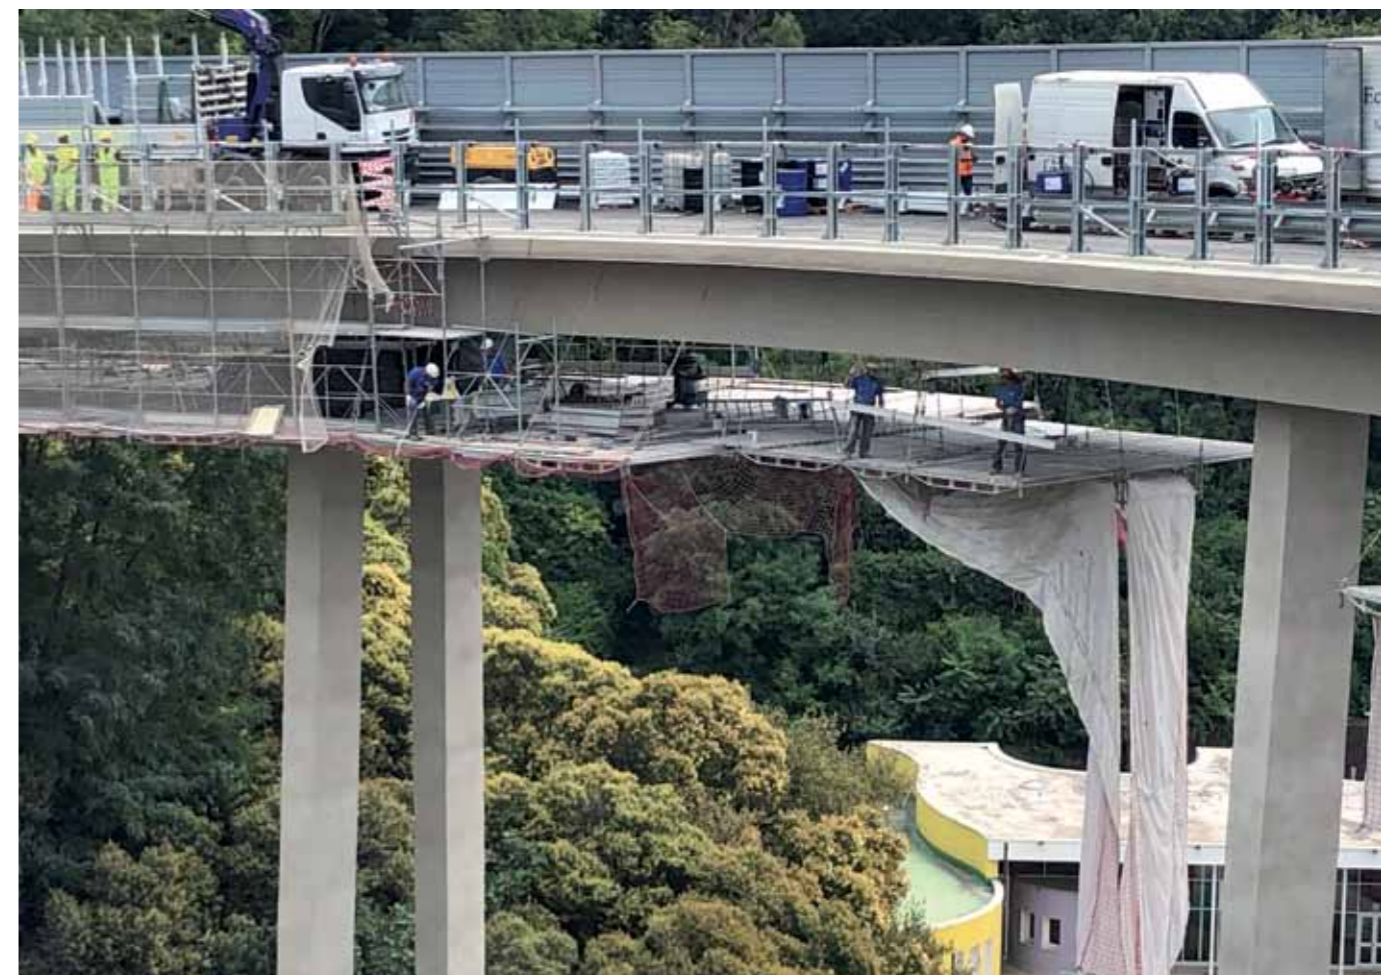
**PURTOP 400 M**

Two-component, solvent-free, hybrid polyurea membrane applied by spray using a high-pressure, bi-mixer type pump to form waterproof coatings on roofs and bridge decks directly on site.
