## Valdaone (Trento, Italy)

## MALGA BISSINA DAM

## REPAIR AND WATERPROOFING WORK ON THE VALLEY SIDE OF THE WALL OF ONE OF THE THREE LARGE DAMS ON THE RIVER CHIESE

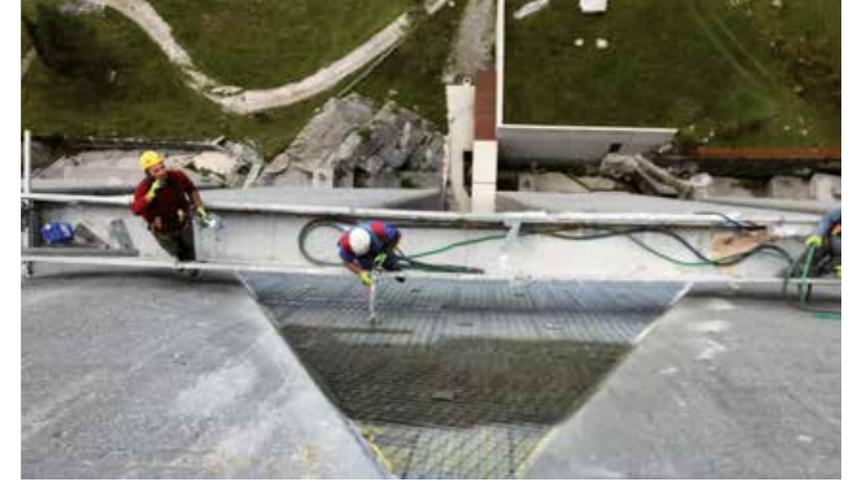
The render on the insulated walls on the valley side of the dam was repaired with MAPEGROUT EASY FLOW. The walls were then waterproofed with MAPELASTIC GUARD.

Then, in 2019, restoration and waterproofing work started on all the insulated walls on the valley side of the dam. The work, which is scheduled to be completed in 2022, includes the use of various Mapei solutions. MAPEGROUT EASY FLOW one-component sulphate-resistant, fibre-reinforced, shrinkage-compensated, thixotropic mortar was used to repair the render. In this case it was admixed with MAPECURE SRA curing admixture to reduce hydraulic shrinkage and the formation of micro-cracks. This mix was then used to integrate areas up to 8 cm thick with a strengthening mesh embedded in it.

The insulated walls on the valley side of the dam were waterproofed with MAPELASTIC GUARD, a two-component, flexible cementitious mortar for protecting large concrete structures subjected to high stress. Due to its high content of quality synthetic resins, its hardened layer maintains its flexibility under all environmental conditions.

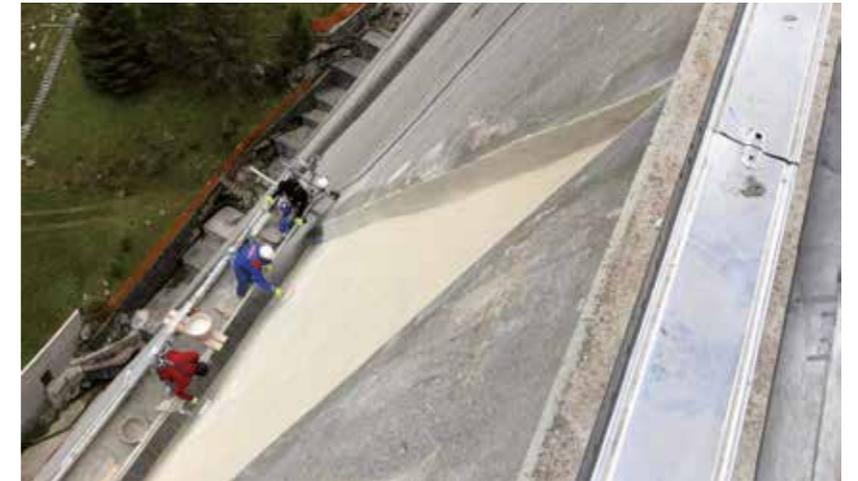
The expansion joints were waterproofed with MAPEBAND TPE tape, bonded with ADESILEX PG4 two-component, low viscosity, thixotropic epoxy adhesive, before sealing them with MAPEFLEX PU30 epoxy-

polyurethane sealant and MAPEFLEX MS45 flexible, thixotropic, quick-hardening silicated polymer-based hybrid sealant.
