Amatrice (Province of Rieti, Italy)

SCANDARELLO DAM

CONCRETE REPAIR AND A NEW WATERPROOFING SYSTEM FOR THE LAKE-SIDE FACE OF THIS CENTURY-OLD DAM

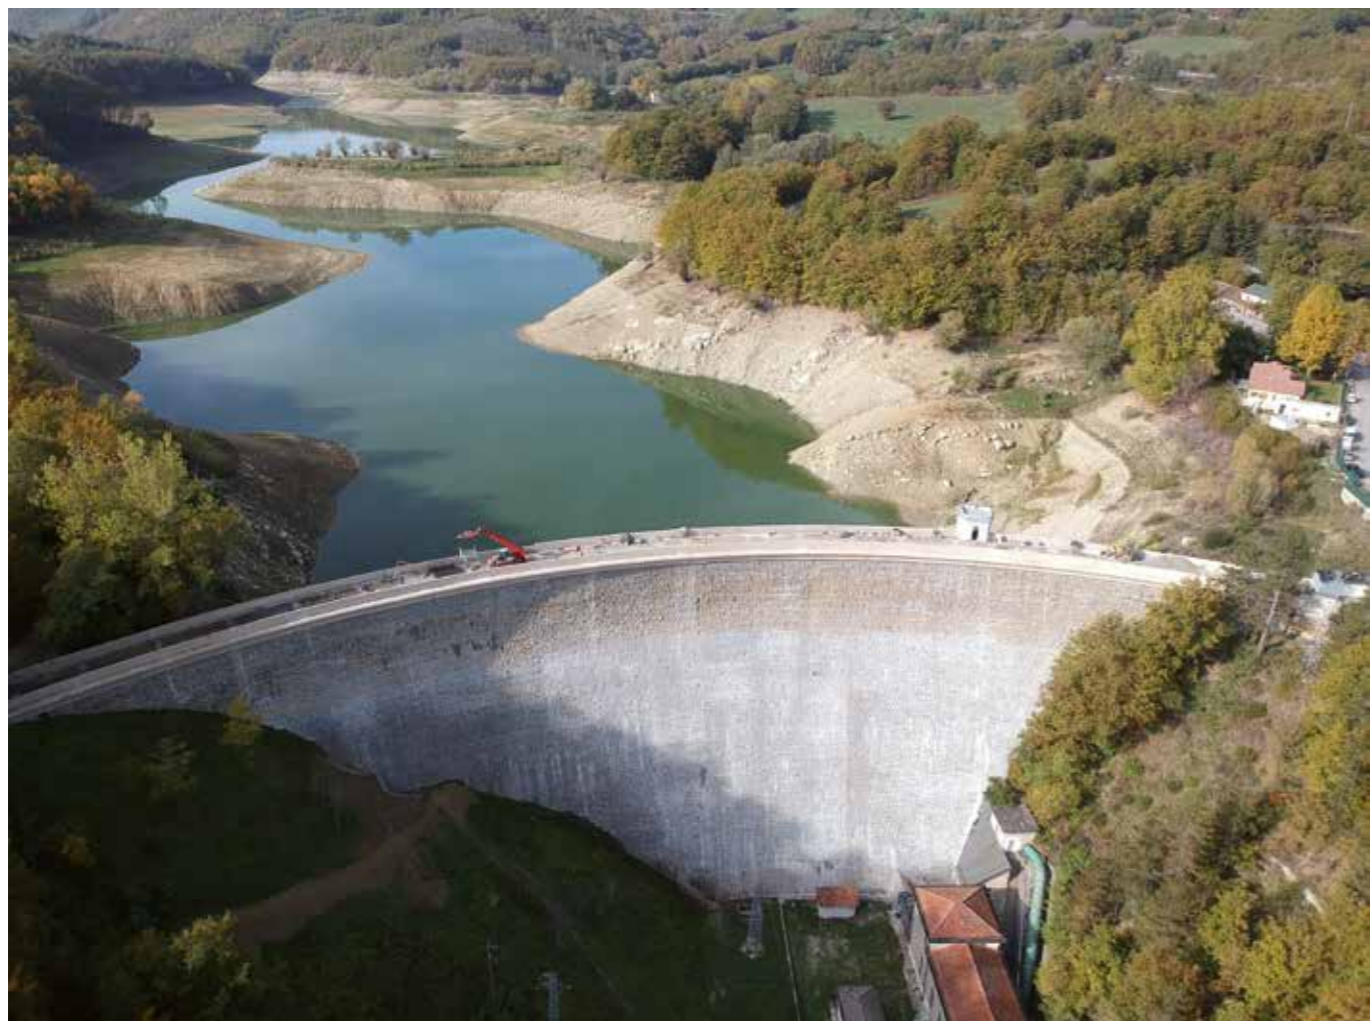
LEFT. The lake-side concrete wall was repaired by applying MAPEGROUT EASY FLOW, sulphate-resistant, fibre-reinforced, shrinkage-compensated, thixotropic mortar.

The lake side of the wall was repaired by applying a large quantity of MAPEGROUT EASY FLOW, one-component sulphate-resistant, fibre-reinforced, shrinkage-compensated, thixotropic mortar which is recommended for restoring concrete structures deteriorated by sulphate salts in the water or ground. To let the expansive properties fully develop in open air, MAPEGROUT

EASY FLOW was admixed with 0.25% of MAPECURE SRA. This is a curing admixture with the ability to reduce hydraulic shrinkage and the formation of micro-cracks.
