THAT CHANNEL ON CICERO'S RIVER

HIGH PERFORMANCE AND CUTTING-EDGE PRODUCTS USED
TO RESTORE AND WATERPROOF CONCRETE

Feeder channel of the Carnello hydro-electric power station, Sora (Italy)

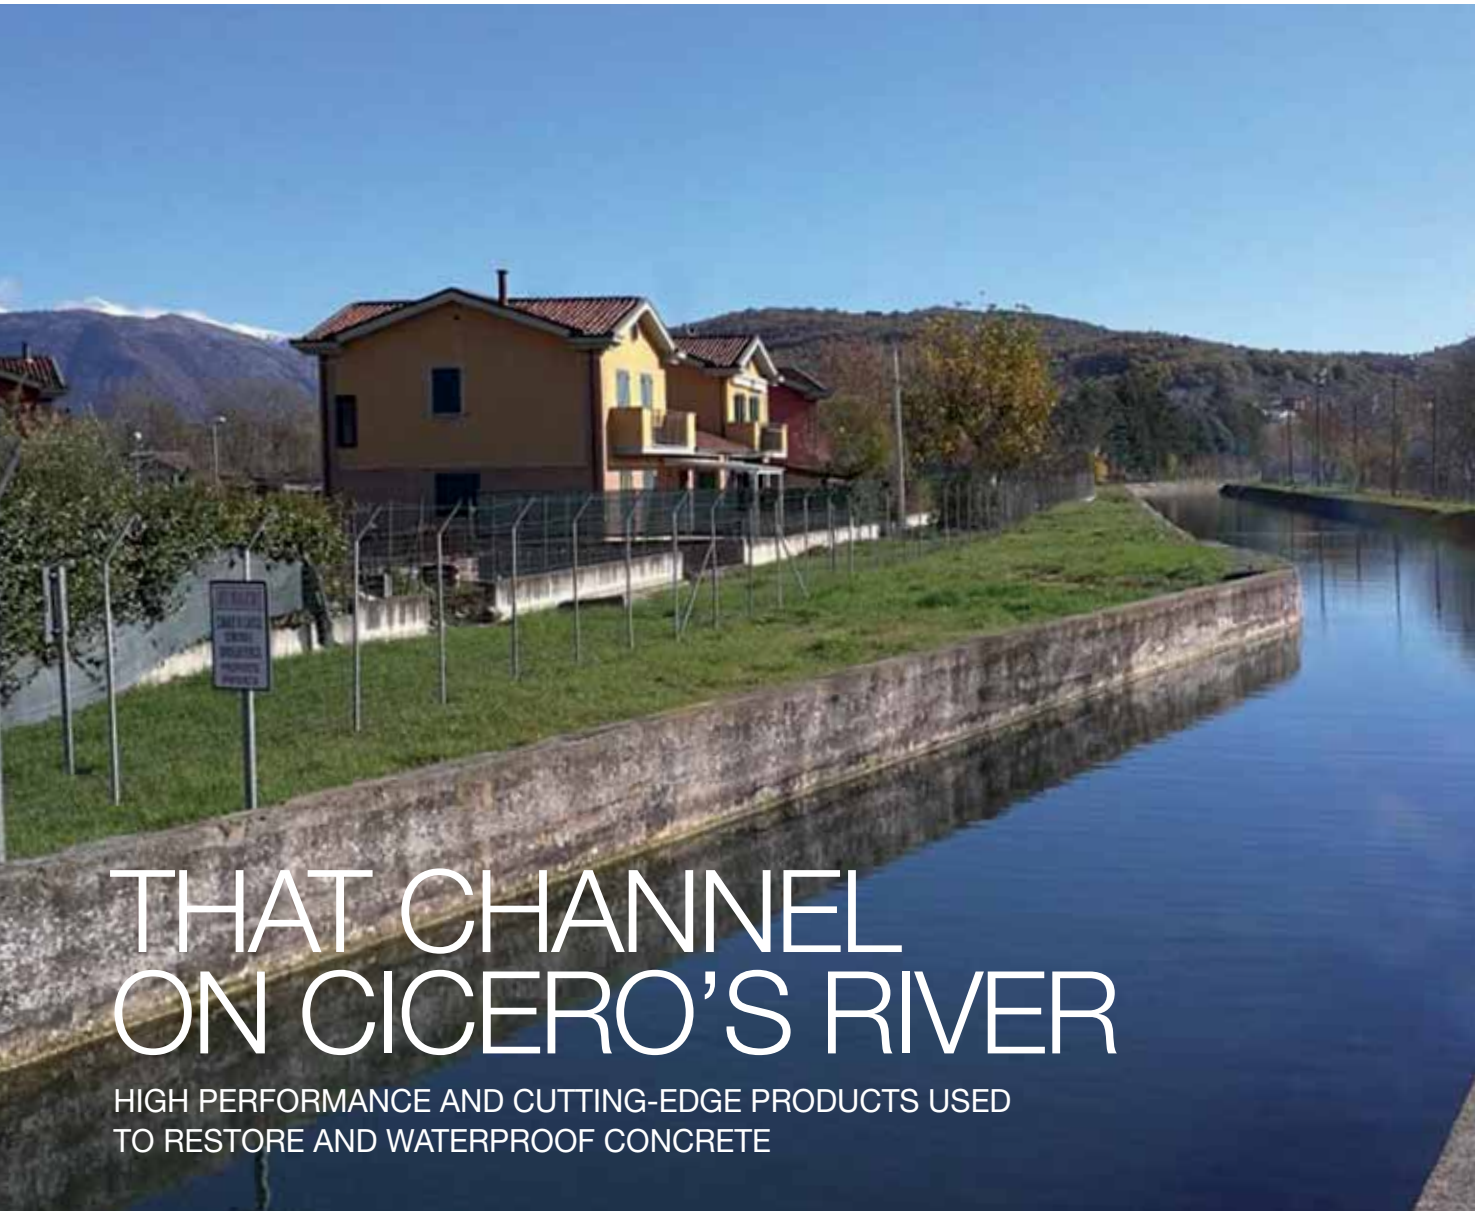
The channel of the hydro-electric power station near Sora (Central Italy) was lately renovated using several Mapei products for concrete repair and waterproofing.

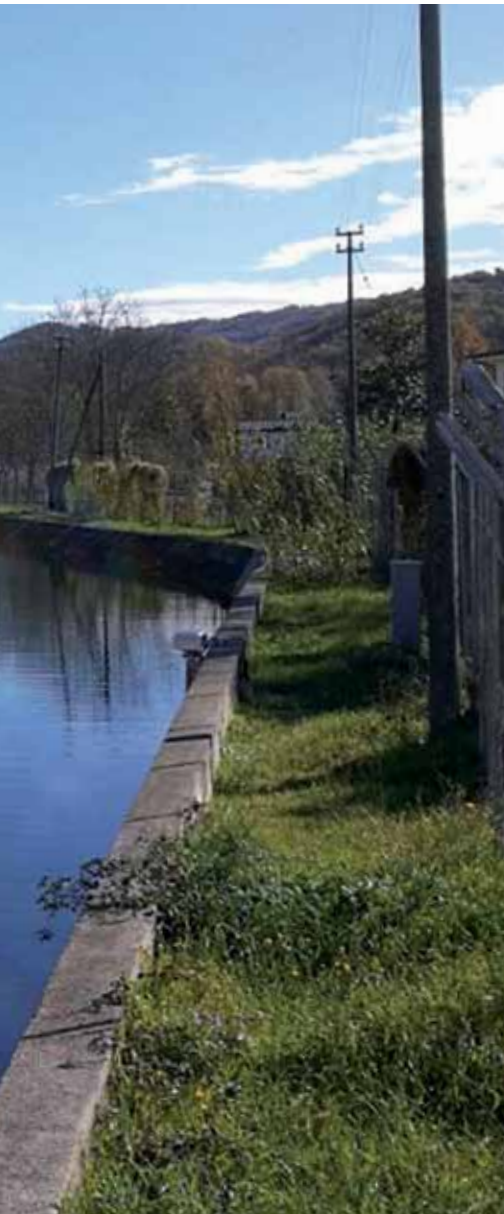
PHOTO 1. Reinforcement rods were treated with MAPEFER 1K cementitious mortar.

The next step was to treat all the reinforcement rods left exposed by brush-applying two coats of MAPEFER 1K one-component, corrosion-inhibiting cementitious mortar to form a layer at least 2 mm thick.

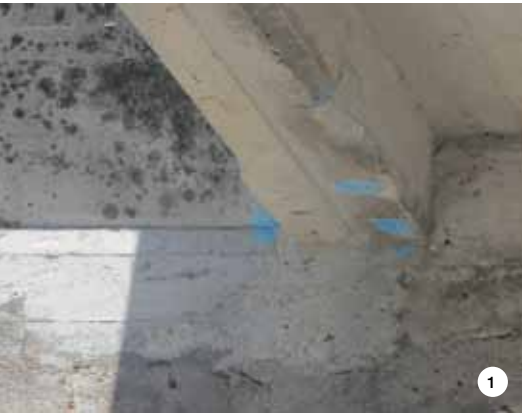
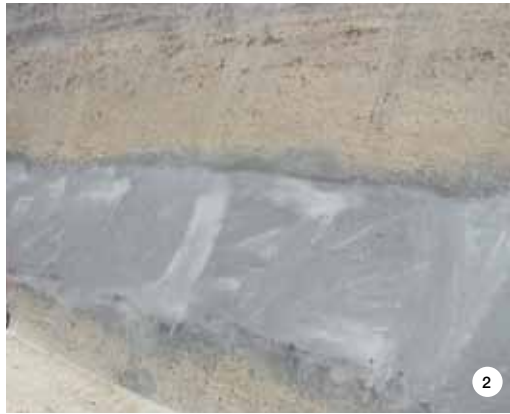
PHOTOS 2 and 3. Damaged concrete areas were repaired with MAPEGROUT EASY FLOW, fibre-reinforced, thixotropic structural mortar, admixed with MAPECURE SRA.

mixed with MAPECURE SRA, a curing admixture with the ability to reduce hydraulic shrinkage and the formation of micro-cracks, at a rate of 0.25% by weight of the mortar.

Taking into consideration the layout of the existing joints in the channel, the concrete was integrated by spray-applying MAPEGROUT EASY FLOW one-component, fibre-reinforced, compensated-shrinkage, sulphate-resistant, thixotropic structural mortar with a worm-screw feed rendering machine. MAPEGROUT EASY FLOW, which also contains corrosion inhibitors, was

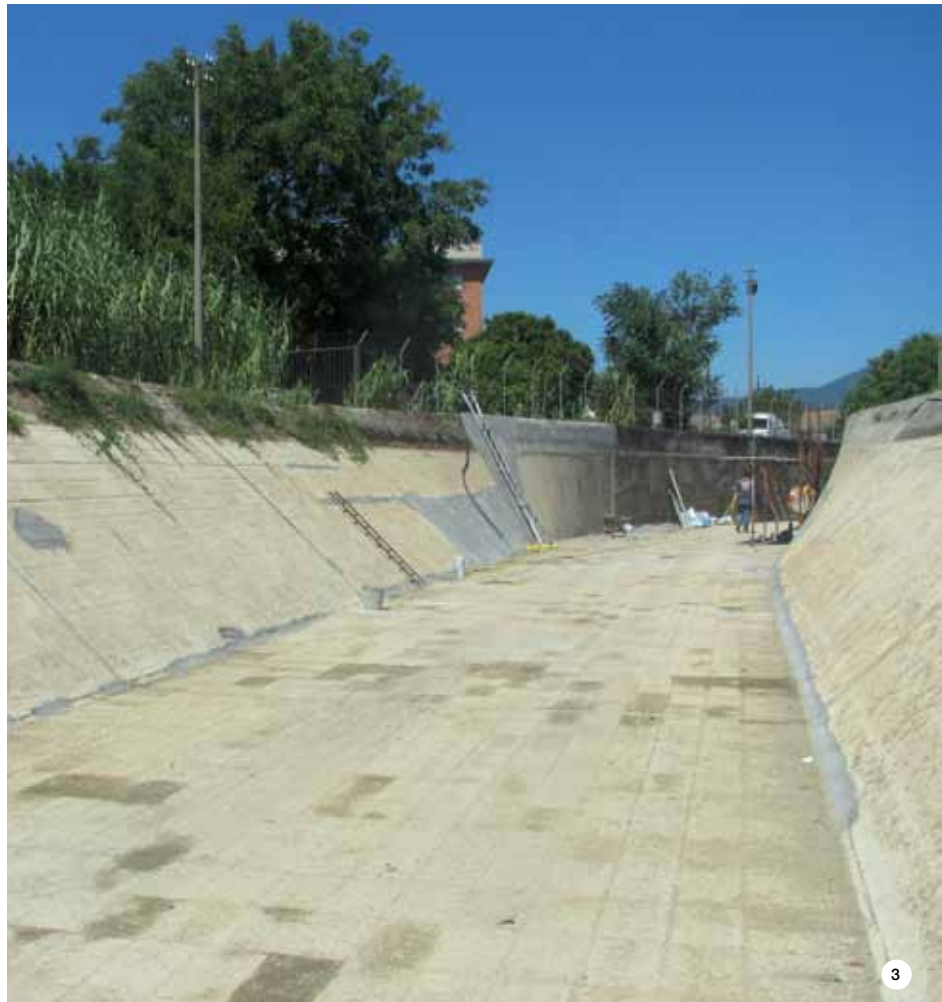
Once MAPEFLEX PU 45 FT was fully cured, MAPEBAND FLEX ROLL flexible waterproofing tape was applied over the joints to ensure a higher degree of impermeability. Once all these operations had been carried out, MAPEBAND TPE tape, specific for flexible sealing and waterproofing of expansion joints subject to movements, was bonded in place with ADESILEX PG4 two-component, thixotropic epoxy adhesive. To guarantee a longer service life for the entire waterproofing system, it was then protected with metal flashing wide enough to cover the MAPEBAND TPE tape, which was anchored in place on one side of the joint and, on the other side, fastened through slots to allow for any movements in the structure.

MAPEFOAM was then placed along the bottom of the joints to gauge the correct thickness. The sides of the concrete joints were treated with PRIMER M, a one-component, solvent-free primer for polyurethane sealants, and filled with MAPEFLEX PU 45 FT sealant.
