# THE BAYER TOWER ON THE OUTSKIRTS OF MILAN

## STRUCTURAL STRENGTHENING OF THE SUPPORT COLUMN AND STORAGE TANK OF THE BAYER EMERGENCY WATER TOWER

### **RENOVATION WORK ON THE EMERGENCY WATER TOWER**

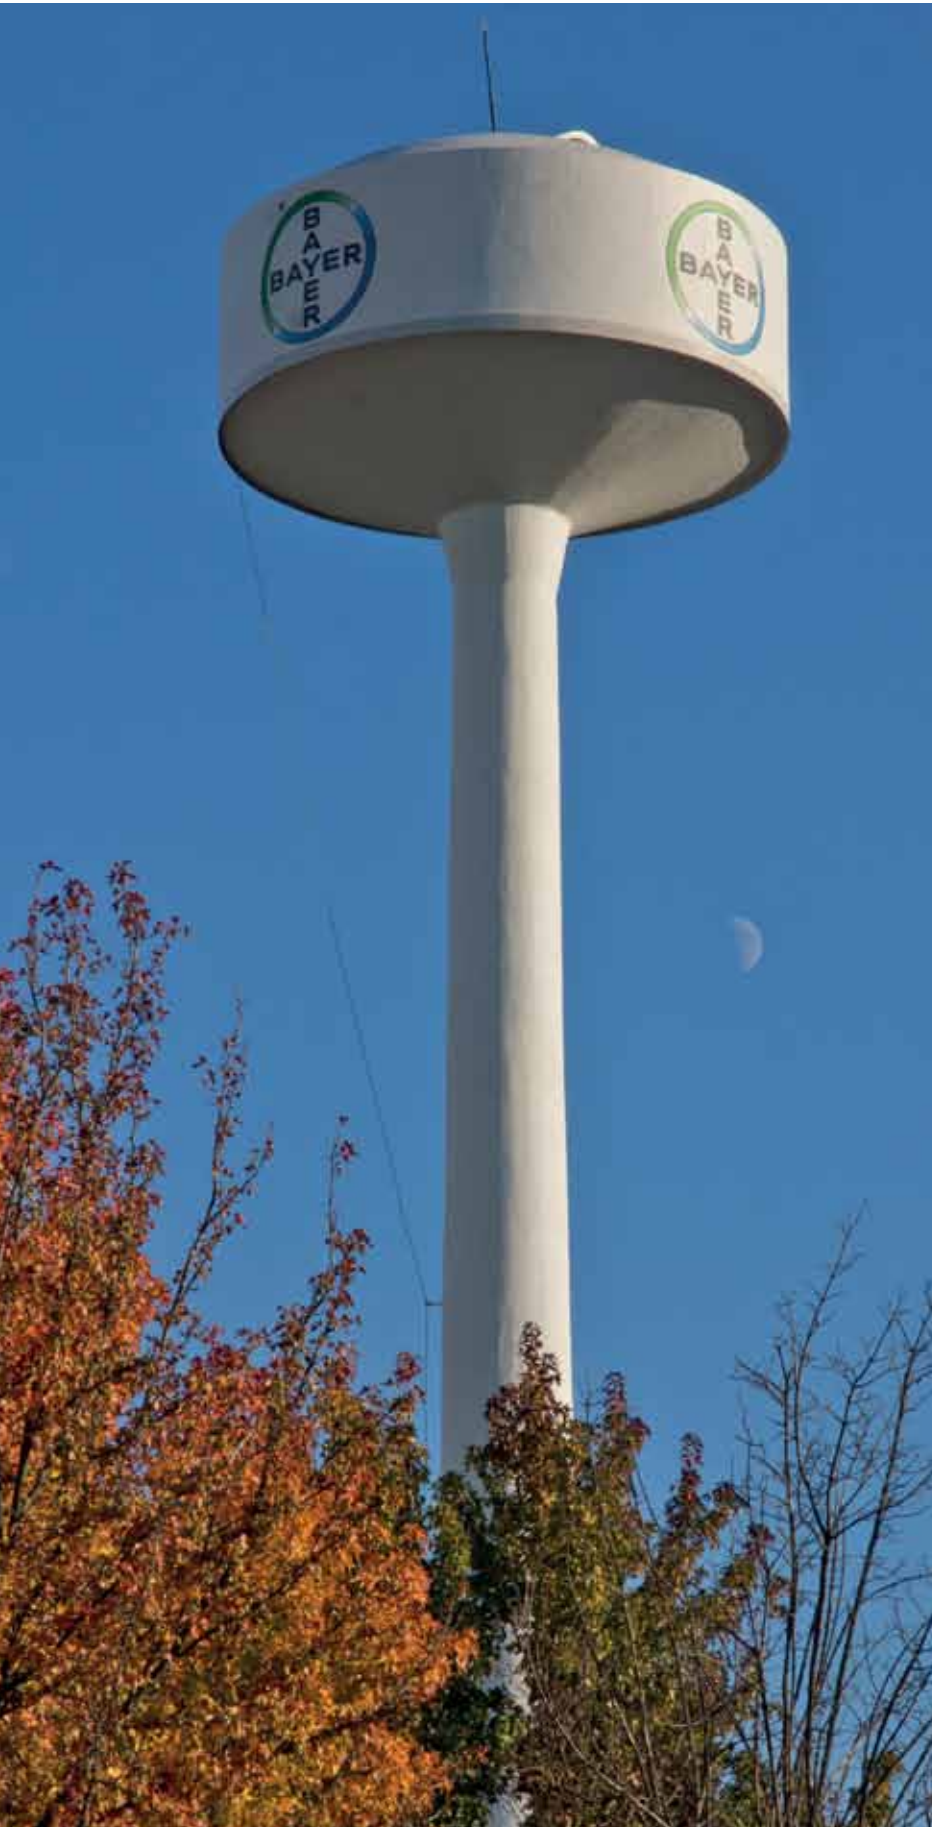
**IN THIS PAGE.** The Bayer emergency water tower.

The structural analysis carried out showed that there was insufficient horizontal reinforcement in the tower, which is required to contrast the formation of vertical cracks and increase the shear strength and ductility through the section.

Working on the external face only was found to be sufficient, by inserting reinforcing material comparable to steel rebar horizontally. The product chosen for this part of the work was MAPEWRAP C UNI-AX high-strength, high-modulus, uni-directional carbon fibre fabric, suitable for confining elements subjected to compressive or combined compressive/flexural loads to improve their load-bearing capacity and ductility.

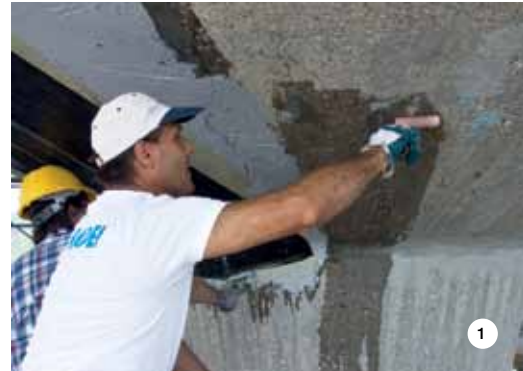
**PHOTO 1.** After preparing the substrate, the surface was primed with MAPEWRAP PRIMER 1.

The first step was to treat the surfaces to be strengthened with MAPEWRAP PRIMER 1, a special epoxy primer specifically developed for the MAPEWRAP system. Then, in the areas that had been repaired and integrated, a layer of MAPEWRAP 12 two-component epoxy grout for structural bonds and composite systems was applied with a spreader. At this point, in correspondence with the position of each ring of strengthening material, a single piece of MAPEWRAP C UNI-AX 300/40 high-strength, uni-directional carbon fibre fabric, impregnated with MAPEWRAP 31 two-component epoxy resin, was wrapped around the column to form a solid ring, with each ring overlapping the adjacent one by at least 20 cm along the horizontal

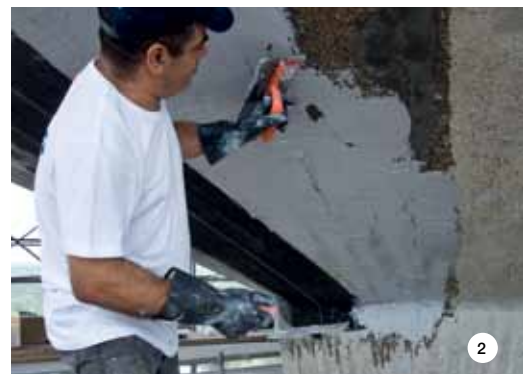
**PHOTO 2.** The surfaces were levelled with MAPEWRAP 12.

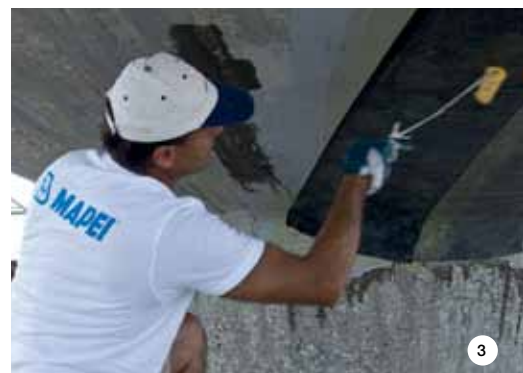
**PHOTO 3.** In correspondence with the position of each ring of strengthening material, MAPEWRAP C UNI-AX 300/40 high-strength, uni-directional carbon fibre fabric impregnated with MAPEWRAP 31 two-component epoxy resin was wrapped around the column.

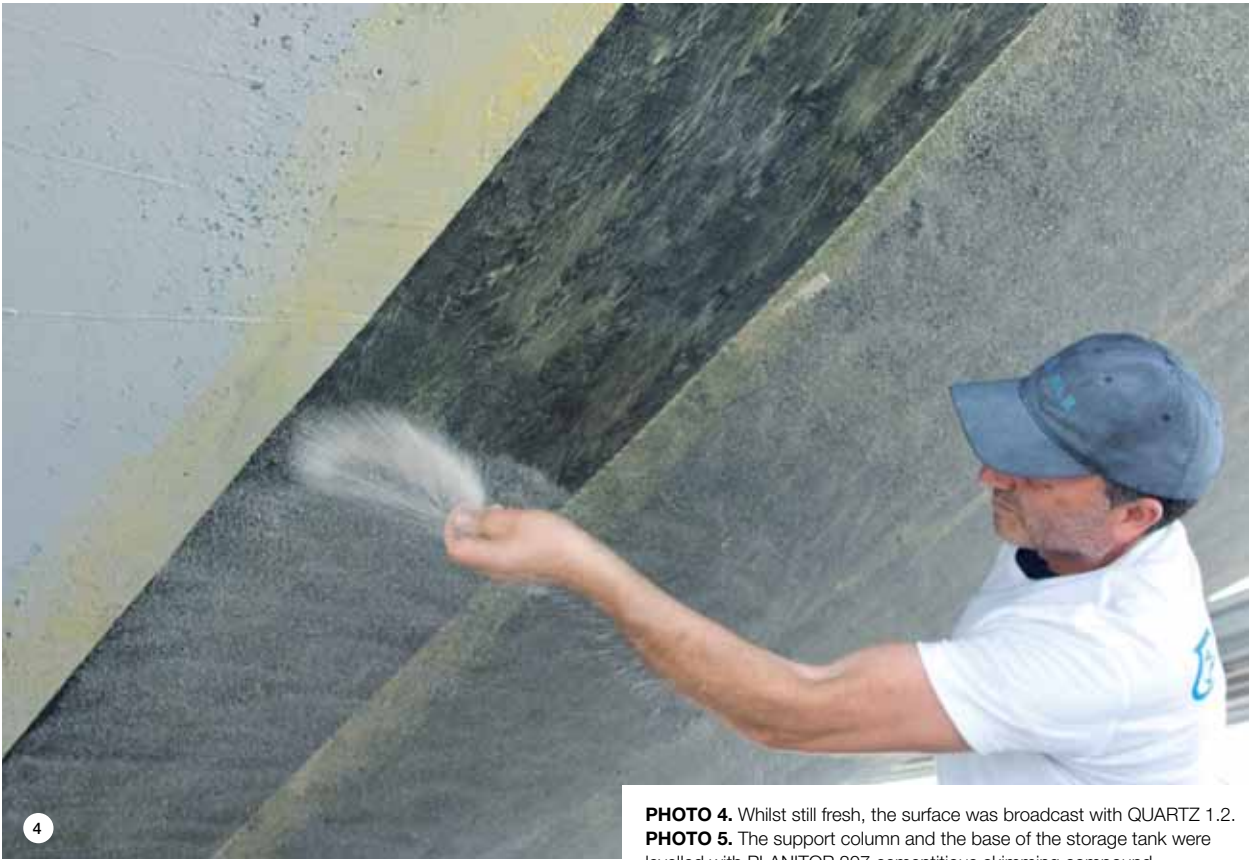
4

**PHOTO 4.** Whilst still fresh, the surface was broadcast with QUARTZ 1.2.  
**PHOTO 5.** The support column and the base of the storage tank were levelled with PLANITOP 207 cementitious skimming compound.  
**PHOTO 6.** Once the surface had been skimmed, it was primed with MALECH.  
**PHOTO 7.** ELASTOCOLOR PAINT was selected for the coloured finish.

plane to guarantee the effectiveness of the confinement work. While the resin on the surface of the fabric was still wet, it was broadcast with QUARTZ 1.2 so that the materials for the finishing operations could form a stronger bond.
