PALAZZO TOMASI DI LAMPEDUSA

THE CONSERVATIVE RESTORATION
WORK ON AN ANTIQUE
ARISTOCRATIC PALAZZO IN PALERMO
INCLUDED THE APPLICATION OF
MAPEI WATERPROOFING SYSTEMS
AND WALL COATINGS

Palazzo Tomasi di Lampedusa, Palermo (Italy)

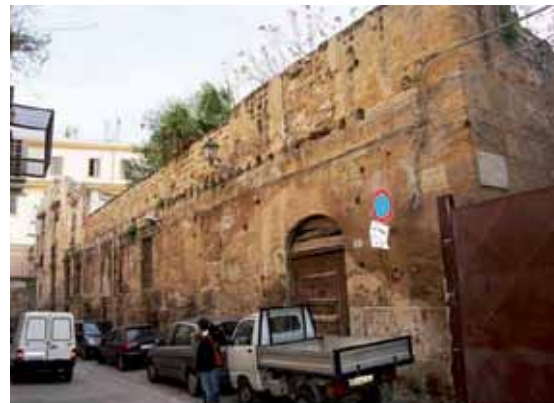
ABOVE. ANTIPLUVIOL W was applied on the masonry walls to provide a colourless, water-repellent protective layer.

The surfaces were primed with QUARZOLITE BASE COAT coloured acrylic undercoat and then finished off with QUARZOLITE TONACHINO 1.2, a coating product for walls with high resistance to all weather conditions. QUARZOLITE TONACHINO 0.7 was used to finish off all the other external surfaces. To make all the surfaces that had been restored water-repellent, it was recommended to use ANTIPLUVIOL W silane and siloxane-based water-repellent impregnator in watery emulsion.

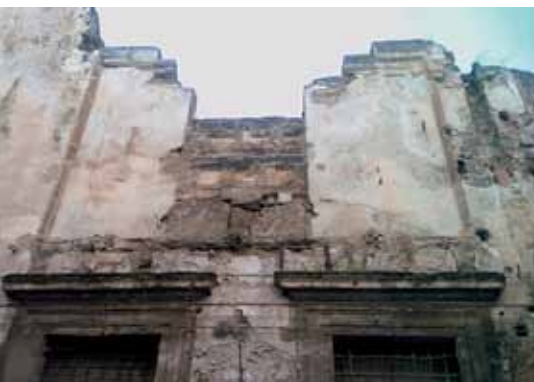
PHOTOS 1 and 2.

The mouldings, window frames and ledges were bonded in place with MAPETHERM AR1.

Mapei Technical Services worked with the designers and contractors with the aim of proposing just the right products for an intervention of this type. MAPETHERM AR1 one-component cementitious mortar was used to bond the mouldings, window frames and ledges while PLANITOP 510 was used for the wall surfaces, a lime-cement skimming mortar forming a fine-textured, natural finish on renders before decorating the surfaces. After a few days, once the compound was completely dry, the surfaces were finished off with the QUARZOLITE system.
